# Detecting micro-cracks

PR Armitage of Theta Technologies and CD Wright from the College of Engineering, Mathematics and Physical Sciences at the University of Exeter, discuss a new instrument and method to detect early stage micro-cracking in concrete by measurement of acoustic harmonic generation.

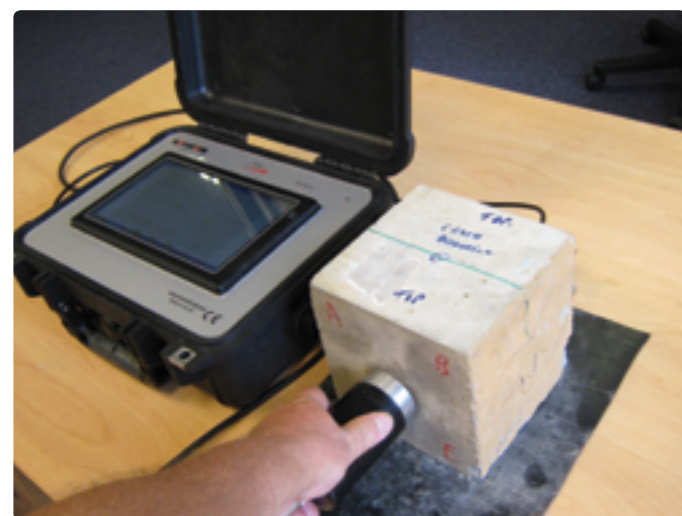
Figure 2: Testing the cube (front view).

Figure 2 shows the front view of the cube, the receiver transducer is held in position by hand. Five locations were tested. The transducer is also coupled by petroleum jelly. The cube is systematically crushed by applying a series of loads to the top surface and measurements taken at each stage.

Figures 2 and 3 show the Maverick1000 being used to test the concrete cube. The transmitter transducer is coupled to the rear cube surface using petroleum jelly and for this experiment supported in a holder at the face centre.

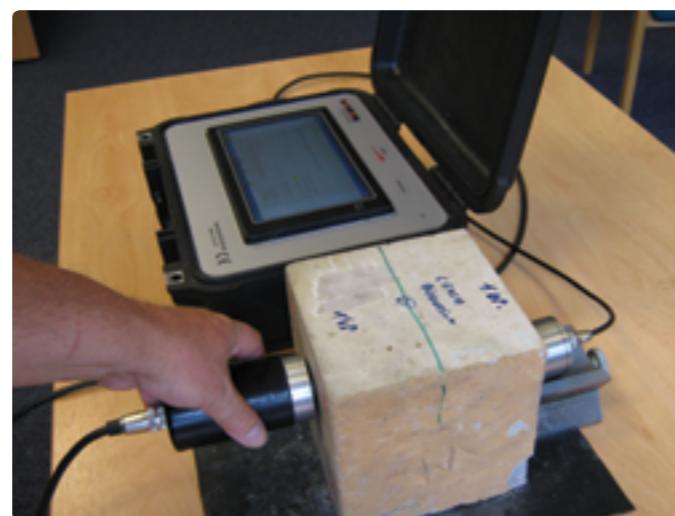
Figure 3: Testing the cube (side view).
